This spreadsheet performs screening level calculations to estimate the effect of peeling leaded paint on the average concentration of lead in yard soil  
3419 Marion Street

| Property ID: 42 | Address: 3419 MARION STREET | Date: 8-17-05 | |

## LBP Assessment Results

# Property ID # 42 / 3419 Marion Street

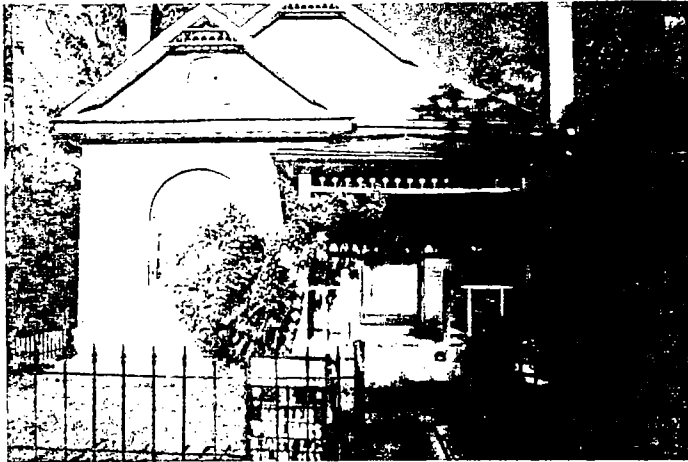
East porch exposure of house

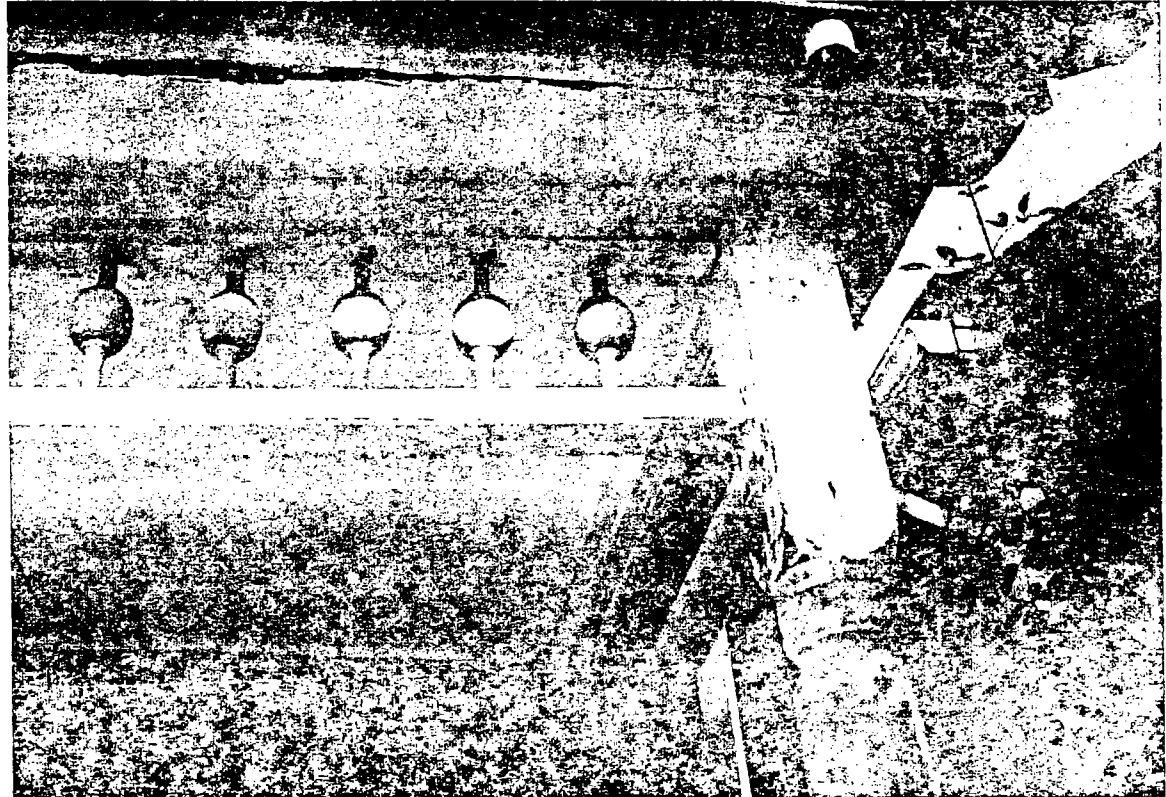
| <b>Time</b> | <b>Site</b> | <b>Component</b> | <b>Substrate</b> | <b>Side</b> | <b>Condition</b> | <b>Color</b> | <b>Floor</b> | <b>Room</b> | <b>Results</b> | <b>Depth Ind.</b> | <b>PbC</b> | <b>PbC Error</b> |
|--|---|---|---|---|---|---|---|---|---|---|---|---|
| 8/17/2005 8:05 | 42 | SOFFIT | WOOD | EAST | PEELING | WHITE | FIRST | OUTSIDE | Positive | 8.05 | 24.9 | 2.2 |

East porch soffit contains peeling lead paint

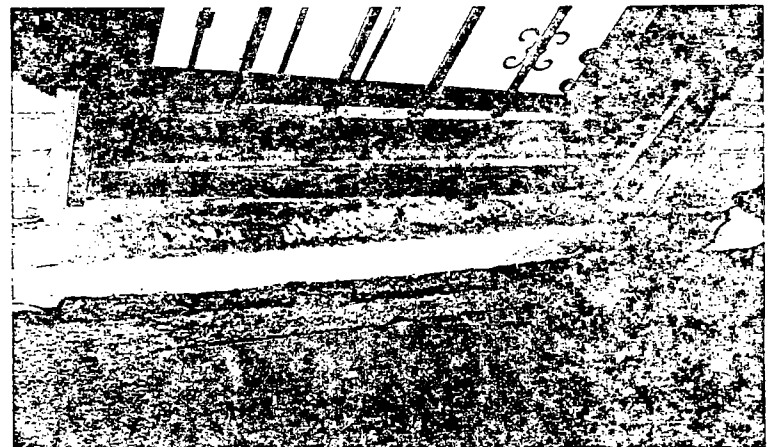
| <b>Time</b> | <b>Site</b> | <b>Component</b> | <b>Substrate</b> | <b>Side</b> | <b>Condition</b> | <b>Color</b> | <b>Floor</b> | <b>Room</b> | <b>Results</b> | <b>Depth Ind.</b> | <b>PbC</b> | <b>PbC Error</b> |
|--|---|---|---|---|---|---|---|---|---|---|---|---|
| 8/17/2005 7:53 | 42 | THRESHOLD | CONCRETE | EAST | PEELING | GREY | FIRST | PORCH | Positive | 6.05 | 4 | 0.7 |

East door threshold contains peeling lead paint
